HUDSON MOTOR CAR COMPANY.. DETROIT 14, MICHIGAN

HUDSON SERVICE MERCHANDISER

HYDRA-MATIC TRANSMISSION CONTROL INDICATOR REPLACEMENT

TIMING CHAIN COVER SHOE

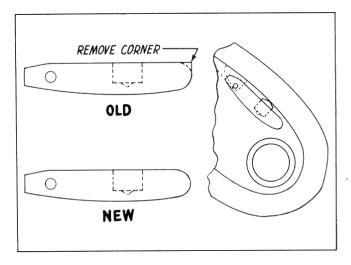
Heretofore, the shape of the trailing end of the timing chain shoe was optional to the supplier, either round or square, as shown in the illustration.

Based upon reports from the field that in some instances there was a noise caused by the sharp corner of the shoe striking the cover, the Engineering Department has specified only the rounded end on all future supplies of this shoe.

In any case of noise reported as mentioned above, the cover may be removed and a hack saw blade used to cut the corner of the shoe off, finish rounding with a small coarse file. It would be in order to do this on all those Timing Chain Cover Assemblies, part number 301342, in your stock that may have the shoe with a square corner.
