HUDSON

Service Merchandiser

VOL. 4 NO. 4

APRIL, 1952

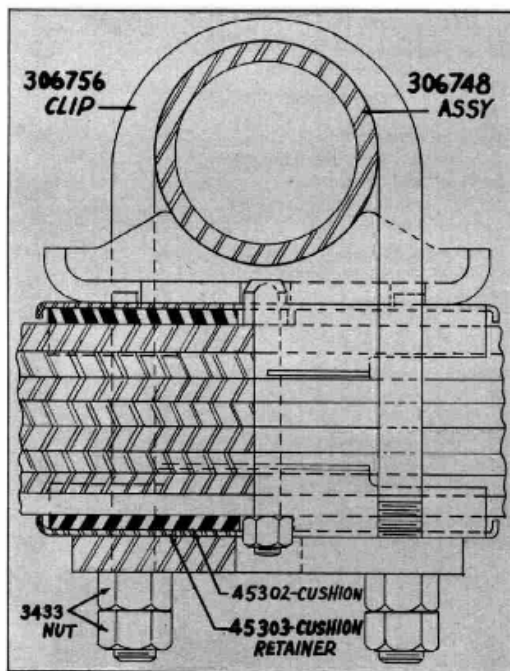
Correct assembly and proper tightening are important for continued satisfactory functioning and wear of spring bolts, bushings and shackles.

When installing new rear springs, the cushions at top and bottom at the U clips should be renewed and all surfaces must be free from grease or dirt. The clip nuts should be drawn up gradually to 70 to 80 ft. pounds. After a few hundred miles, the clip nuts should be checked and if necessary, tightened to 40 to 50 ft. pounds. This because the rubber cushions have become set and any tighter than this would neutralize the effects of the rubber cushions.

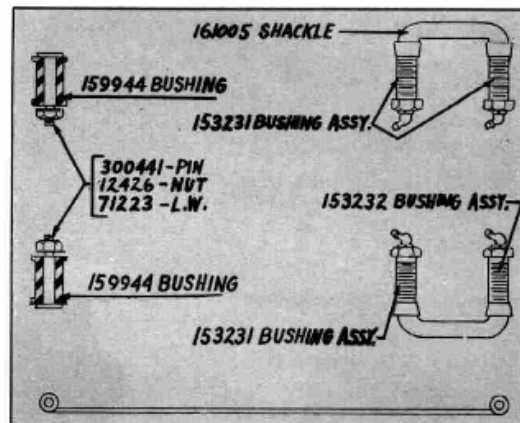
Note carefully the sketch of the shackle arrangement—three bushings have a right hand thread, while the one in the left rear spring has a left hand thread. The object of this is to prevent the bushing in the left spring from having a tendency to work out due to the action of the shackle.
