1957 AMC-Hudson

Body Group &
Groups 1.000 thru 13.000

INDEX

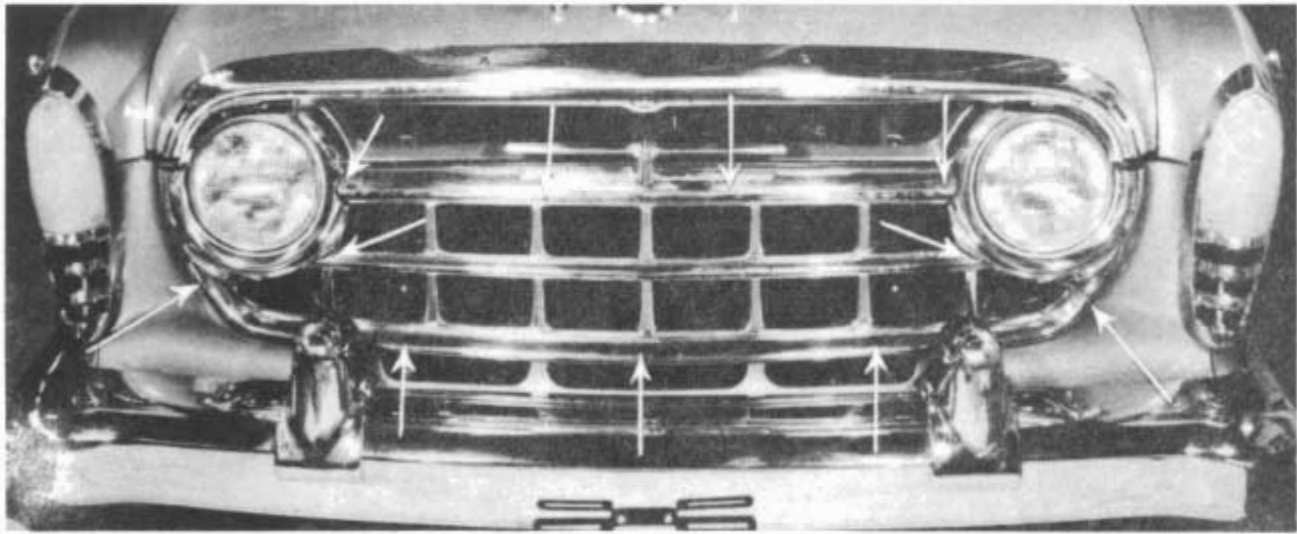
"RAMBLER" SERIES GRILLE REMOVAL

Arrows indicate location of nuts and washers
to be removed from grille anchoring studs.

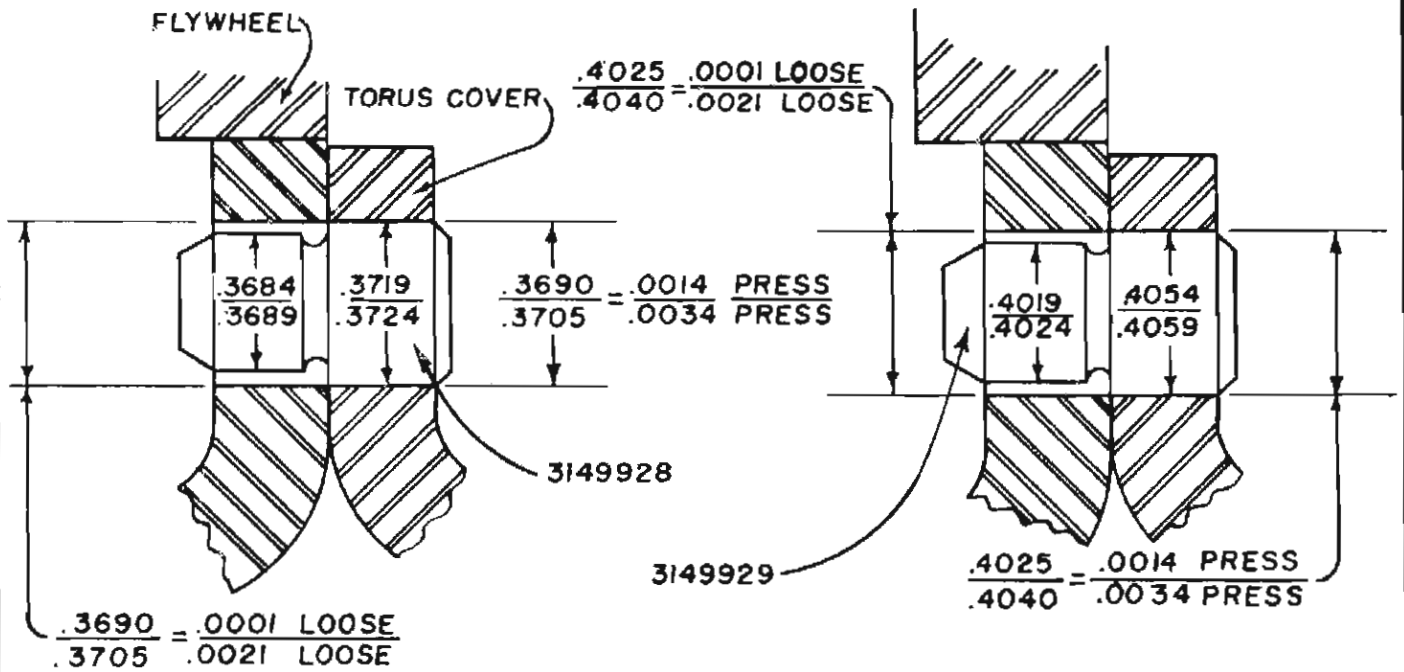
1956 DESIGN

The 1957 torus cover assembly will not contain the two locating dowel pins found in the 1956 torus cover. The dowel pins are pressed into the 1957 flywheel assembly.

CHANGE TO STRAIGHT DOWELS - FLYWHEEL TO TORUS COVER

To provide complete interchangeability, two dowel pins will be serviced loose as part of the torus cover assembly service package.

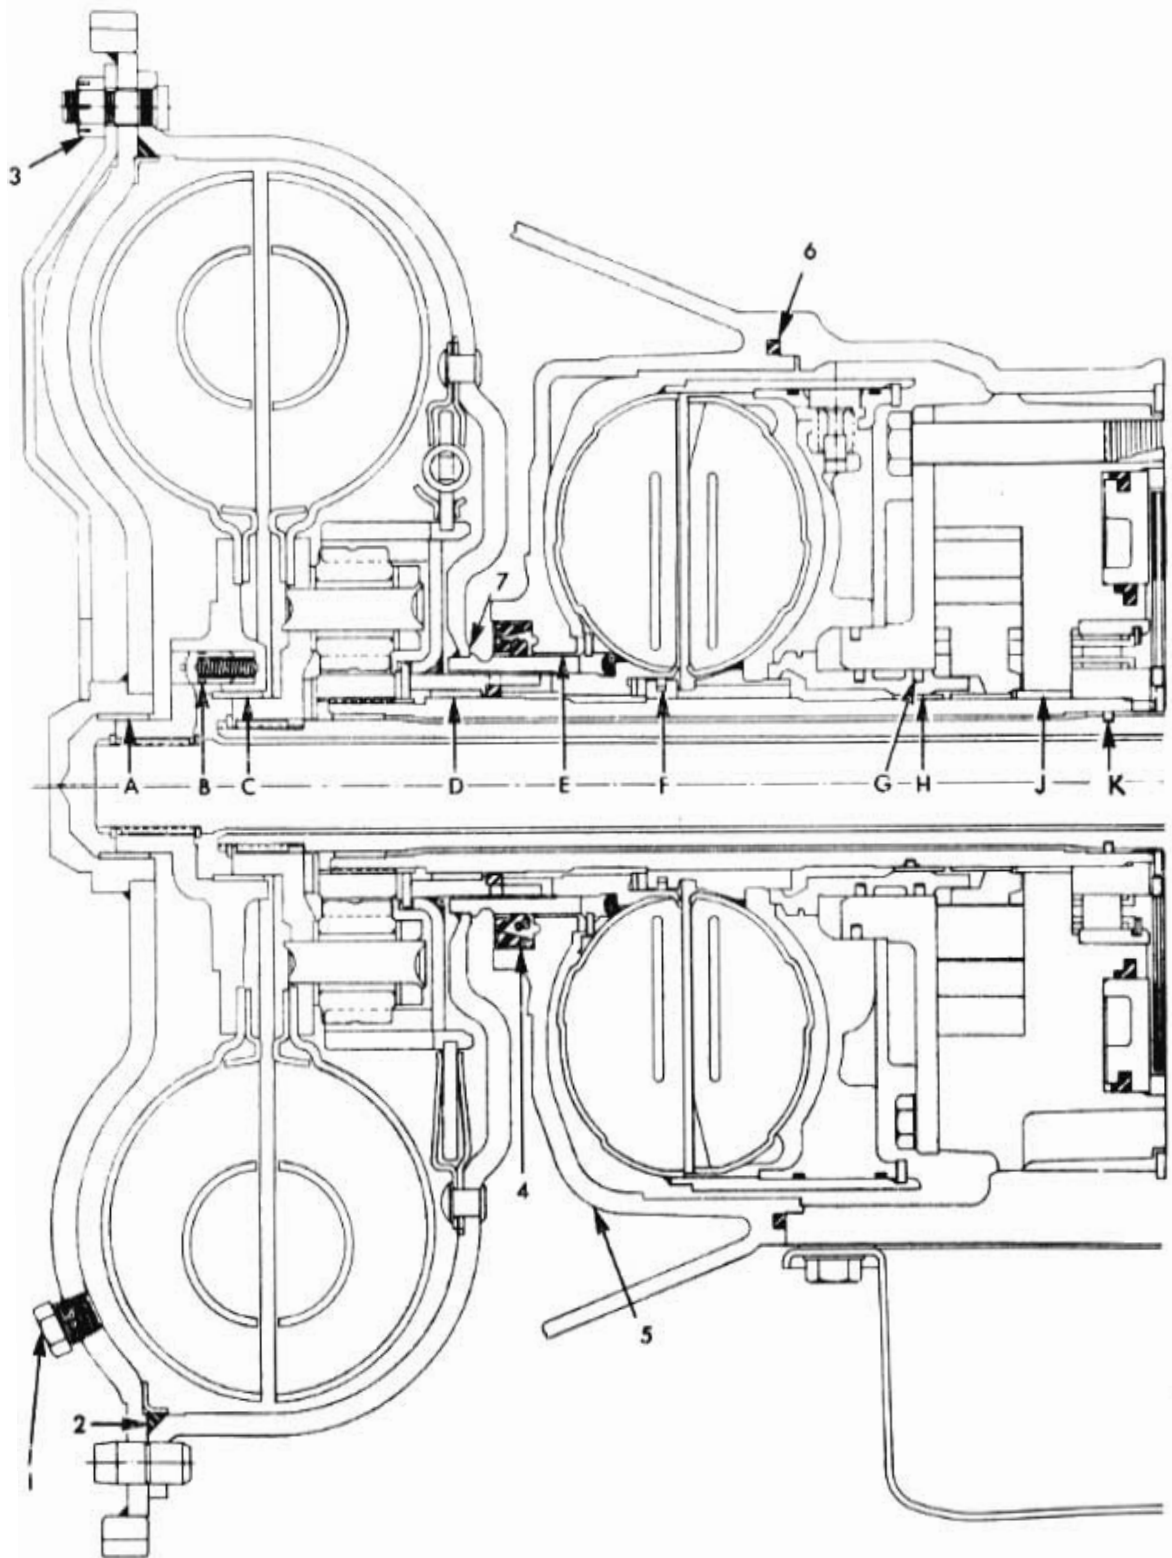
For other possible oil leaks, the following points, also shown in the attachment, should be checked.

1. Torus drain plug loose or improperly installed.

2. Torus Cover to Flywheel Seal Not Installed Properly or damaged

4. Front Seal Leak

Check the front seal to see that it is correctly installed and is not damaged. When installing a new front seal, make sure the bore is free from staking material and that the garter spring on the seal is correctly positioned. Also check the torus cover neck finish and the bushing in the flywheel housing.

Inspect weld at torus cover neck for possible leak.

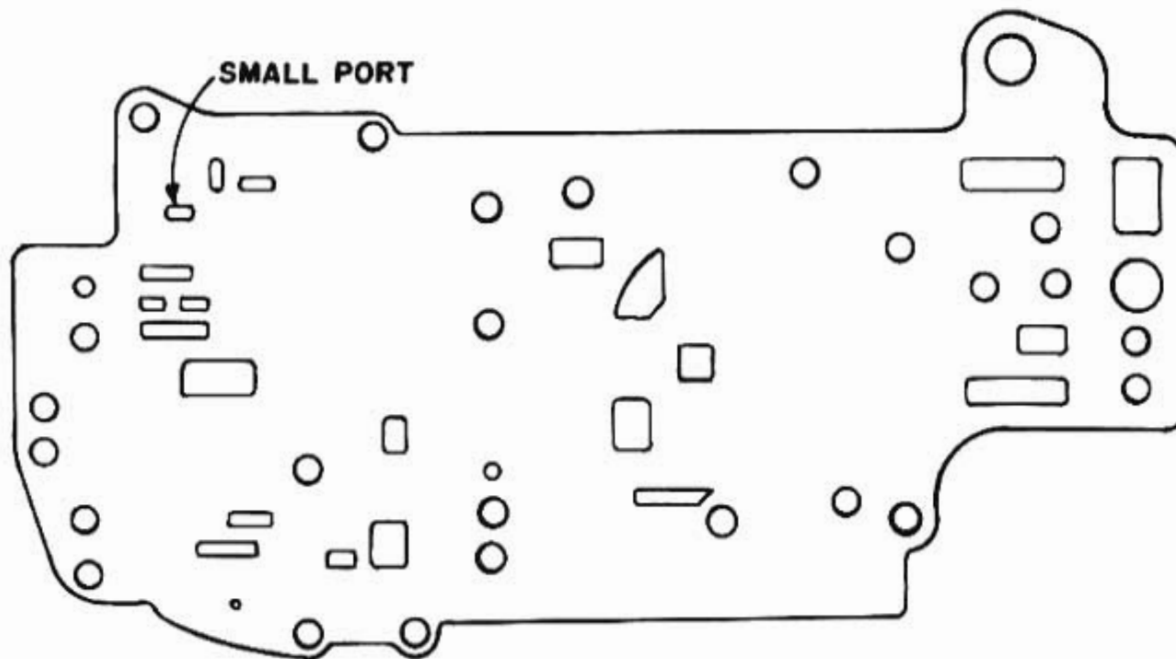
NEW STYLE SPACER PART N^o 3149956

The use of the old style spacer with the revised Manual Valve Body Assembly will allow excessive IILII range oil leakage at the Manual Valve Body. The resultant insufficient IIL" range oil pressure could cause low band failure.

Only the revised Manual Valve Body and Spacer will be available for service replacement.
