# Convice Mendaliani Convic

Vol. 2 No. 2

February, 1950

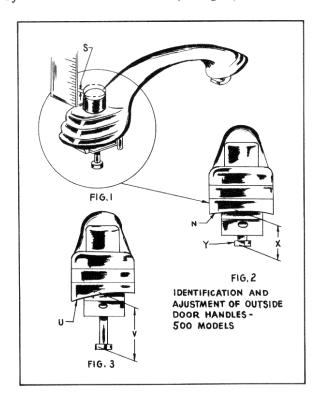
The outside door handles used on the 500 model Pacemaker Brougham and Sedan front door, part number 220720 are identical except for the distance the end of the adjustable plunger (Y-Fig. 2) projects beyond the base of the handle. This handle is supplied for servicing both types of doors and can be distinguished from the rear door handles by the contour of the base (N-Fig. 2).

When making installation on a Sedan front door the plunger which is screwed into the handle, is turned in or out as required, until the dimension (X-Fig. 2) measures 23/32". For Brougham and Coupe doors the plunger must be adjusted so that it projects 51/64". If these measurements are less than the above, it is likely that the lock will not be released when the outside handle button is pushed in all the way. On the other hand, if the dimensions are greater than given here, it may be impossible to unlock the door either with the key or by pulling up the inside release button.

In the case of the rear door outside door handles for Pacemaker Sedans, part number 220724 has been assigned for the right and number 220725 for the left door. These handles can be readily identified by the shape of the base as shown at (U-Fig. 3). The dimension (V-Fig. 3) should be 1-7/32". and is obtained by screwing the plunger in or out

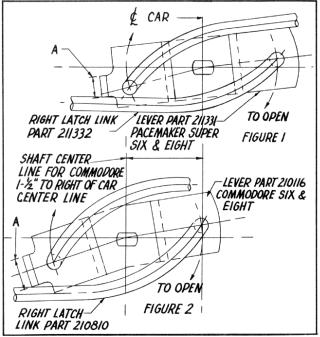
A condition in which the rear compartment door may be opened even though the handle is locked or inability to unlock the door, may be attributed to the door latch operating lever and linkage assembly.

When either of the above conditions exist, visually check the door latch operating lever to determine that the correct lever is installed. Referring to the sketch it will be noted that the lever, Figure #2, Part #210116, as used on 480, 490 and 500 Commodore Models is mounted approximately  $1\frac{1}{2}$ " to right of center line of car and differs from the lever in Figure #1, Part #211331 used on 500 Pacemakers 480, 490 and 500 Supers, in that it has an 8 degree angular bend and the stop A is 3/16" wider.

If by error the Commodore latch lever should be installed on the 500 Pacemaker or Super Series, the angularity of the lever causes the stop A to contact the latch link before a positive over-center position has been obtained. It is then possible to pull the door open with the handle in the locked position. If the Pacemaker or Super Series latch lever should be installed on the Commodore, a condition will exist where the lever is permitted to rotate too far, making it impossible to unlock the handle since the shaft is rotated past the point of engagement with the key cylinder.

With the correct levers installed and the above conditions existing, the following method may be used for correction:

Should the door open in the locked position, this indicates that the right latch link is too short. Replace with a new link of the correct type. If a new link is not available, the stop A may be cut back  $\frac{1}{8}$ " to allow more rotation of the lever.

If the handle cannot be unlocked, this indicates that the right latch link is too long permitting excessive travel of the lever. This may be corrected by putting a reverse bend in the right hand link to bring the bend into closer engagement with the stop of the operating lever.

When in proper adjustment the rear deck handle should have approximately 1/4" spring back from the full closed position with the handle unlocked.
