1955 AMC-Hudson

Technical Bulletins (Groups 1.000 thru 13.000)

INDEX

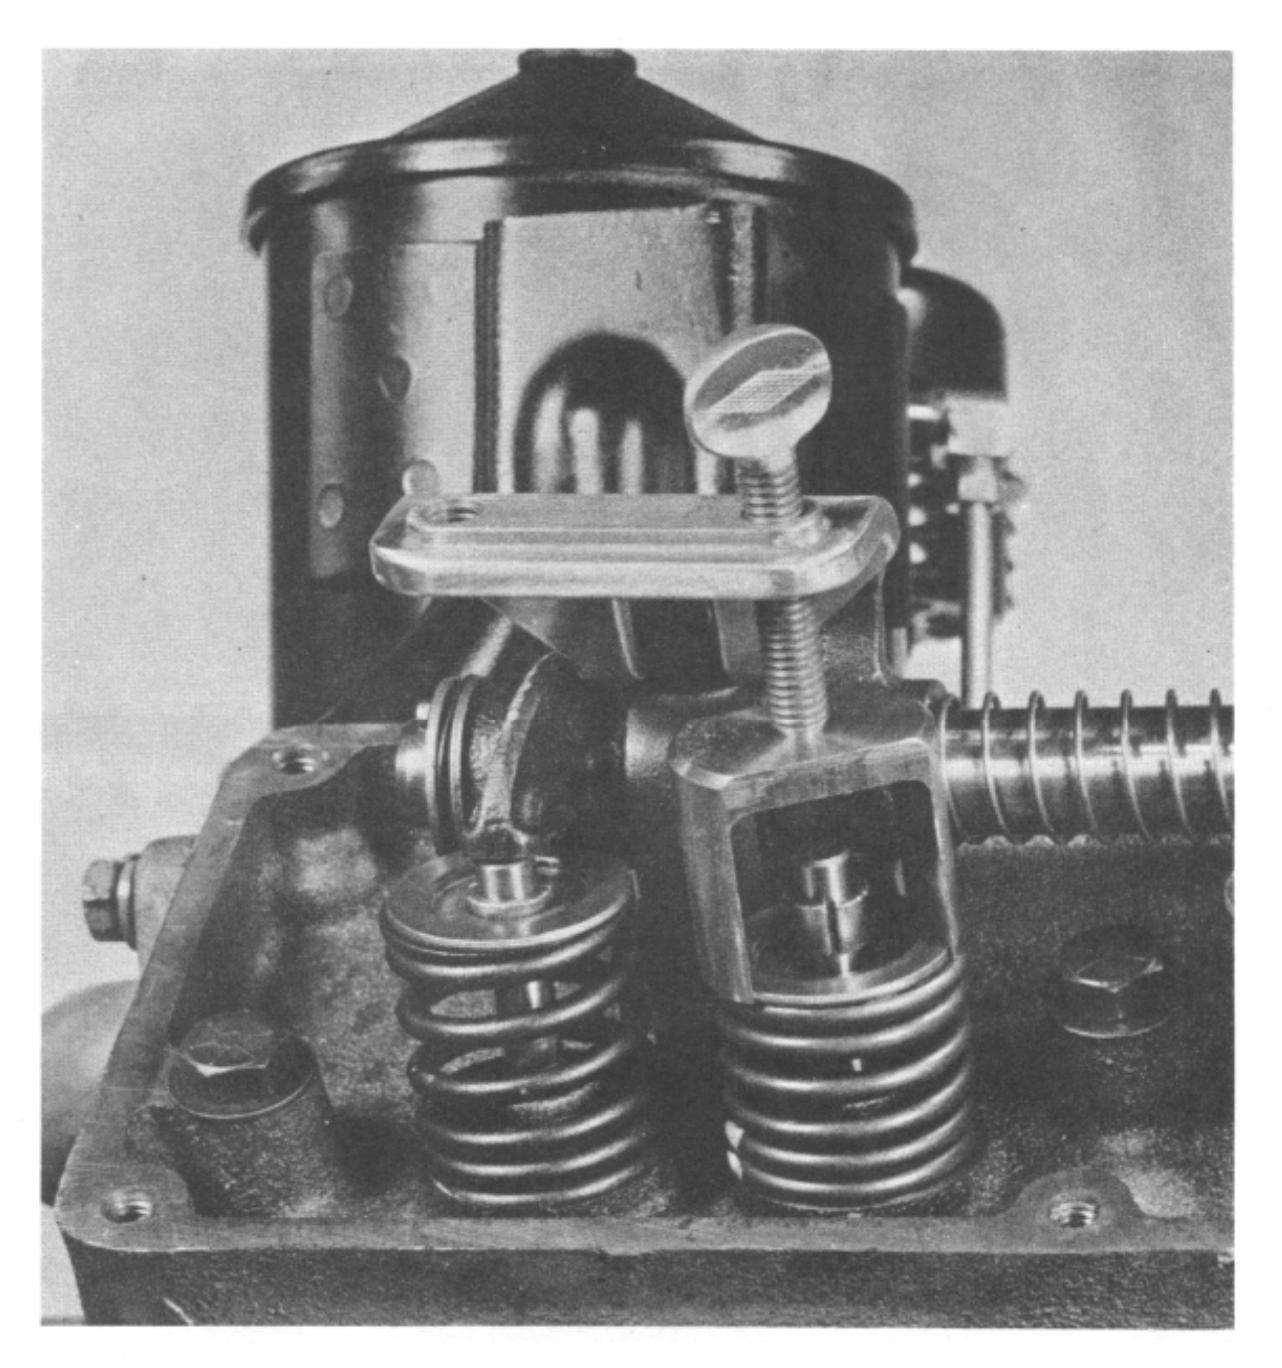
FIGURE 1 Removing Valve Spring With Tool J-6204 (Sample Tool Shown)

To remove the valve spring, locate the piston on TOP CENTER to contact the valve head when the valve spring is

depressed. Remove valve cover and loosen rocker arm shaft assembly.

Locate Tool J-6204 on the rocker arm shaft. support and retain with the mounting bolt. Install the "U" shaped adapter

inverted position on the spring retainer . Depress the spring with thumb screw to remove the split valve locks. Release spring tension and remove valve spring.

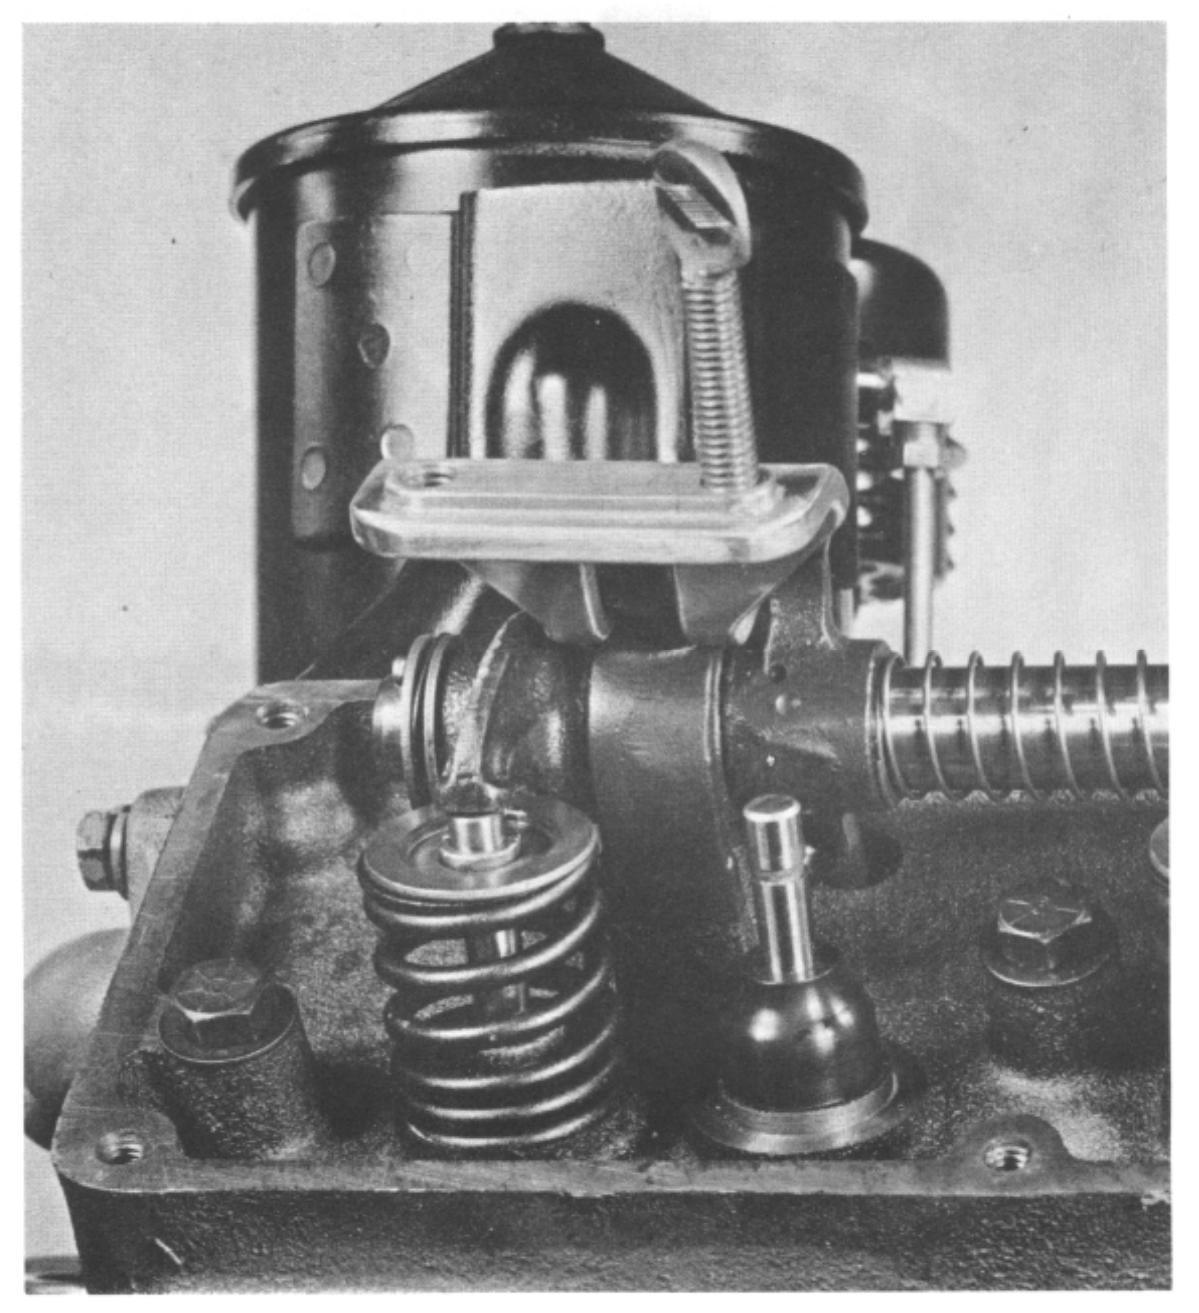
Part Number 6476056, Intake Valve Stem Oil Deflector, became effective at Engine Number P-13644 for improved oil control. This is in addition to the elimination of the eight oil holes in the rocker arm shafts which became effective at

The deflector, a rubber cap, is located over the valve stem and installed on the top section of the cast valve guide.

FIGURE 2 Part Number 6476056, Oil Deflector, Installed on Valve Guide

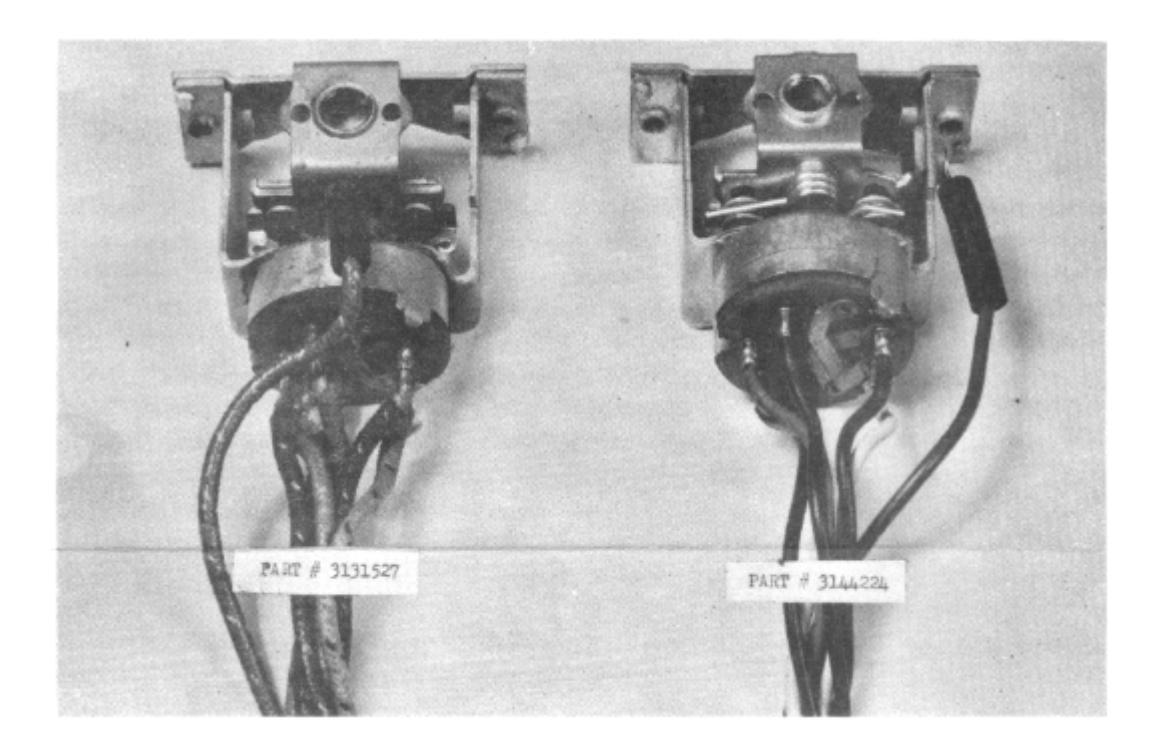
FIGURE 1

American Motors Technical Service Att. #55-37 illustrates Part Number 3144224 Directional Signal Switch assembly which became effective at car Serial Numbers W-1119, X-1090, and Y-1177. Switch, Part Number 3131527, used prior to these serial numbers is also illustrated for comparison purposes.

Directional Signal Switch Assemblies

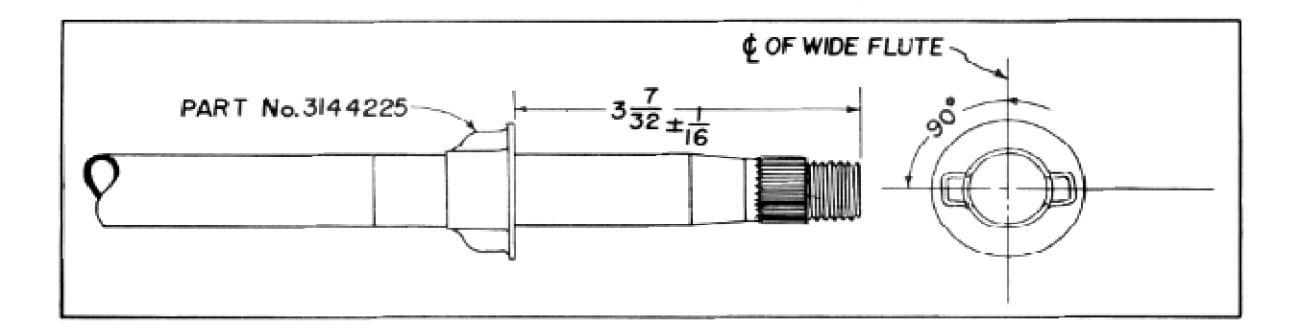
FIGURE 2

Directional Signal Switch Cam, Part Number 3144225, designed for use ONLY with switch, Part Number 3144224, MUST BE INSTALLED AS ILLUSTRATED IN FIGURE 2.

The installation of parts not designed for operation with each other or the mislocation of the cam on the steering column tube will definitely result in premature failure of the switch assembly.

Directional Signal Switch Cam Location 1955 "Hornet" and "Wasp" Series

Apply a slight amount of Lubriplate to the switch levers and rollers, operating cam, and the jacket tube opening cover prior to installation of the switch.

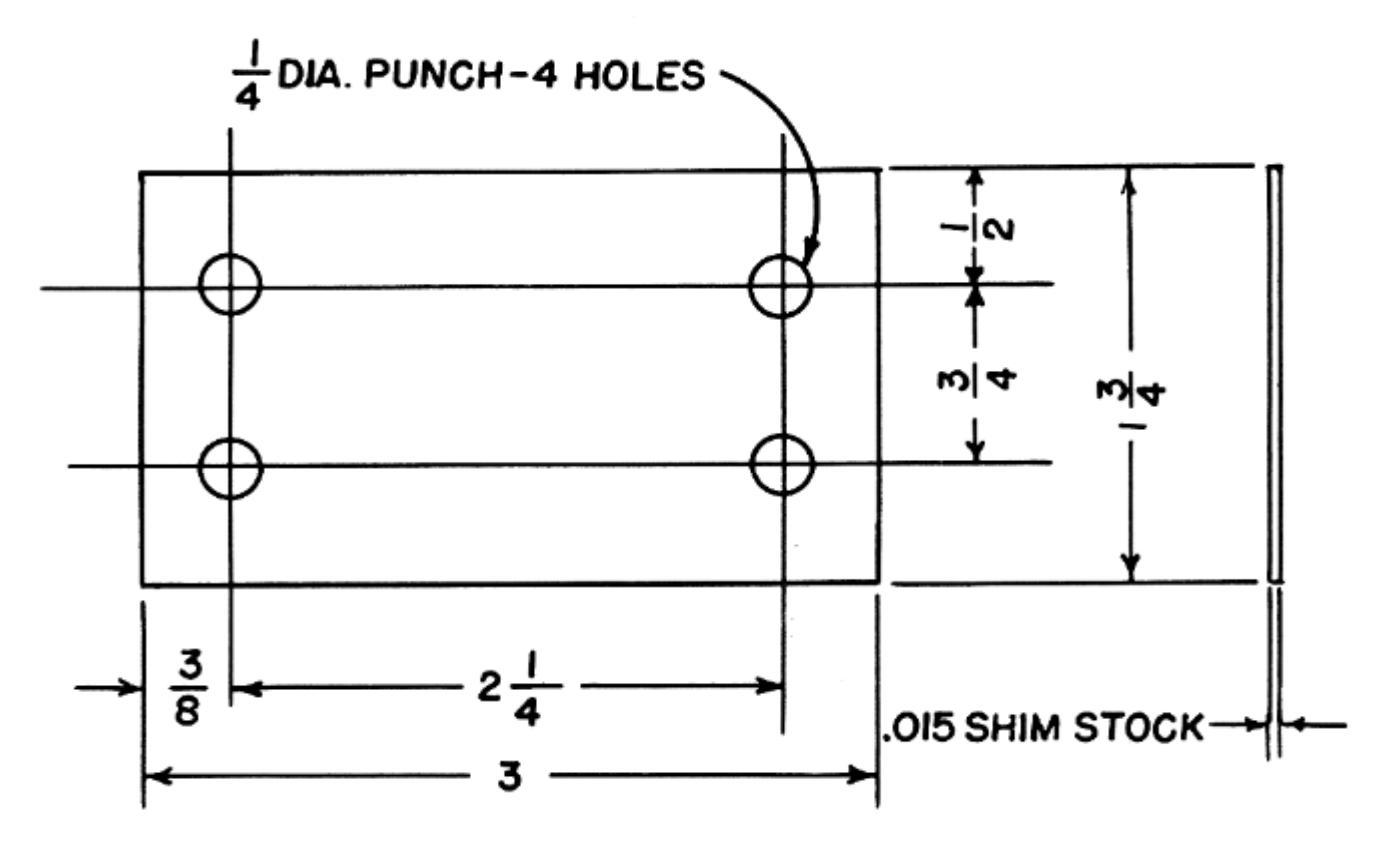
Where difficulty is encountered, a clutch beam fabrica insulator reinforcement shim may be incorporated in the beam assembly to prevent distortion or cracking of the insulator.

Clutch Beam Insulator Reinforcement Shim

As this part, at present, is not available, American Motors Technical Service Att. #55-22 illustrates the size of a shim which can be fabricated from ordinary .015" shim stock.

Remove the four bolts that retain the insulator and add the shim to either side of the insulator and torque tighten to 4 foot pounds. Replace the fabrica insulator if the original one shows signs of distortion or elongated holes.

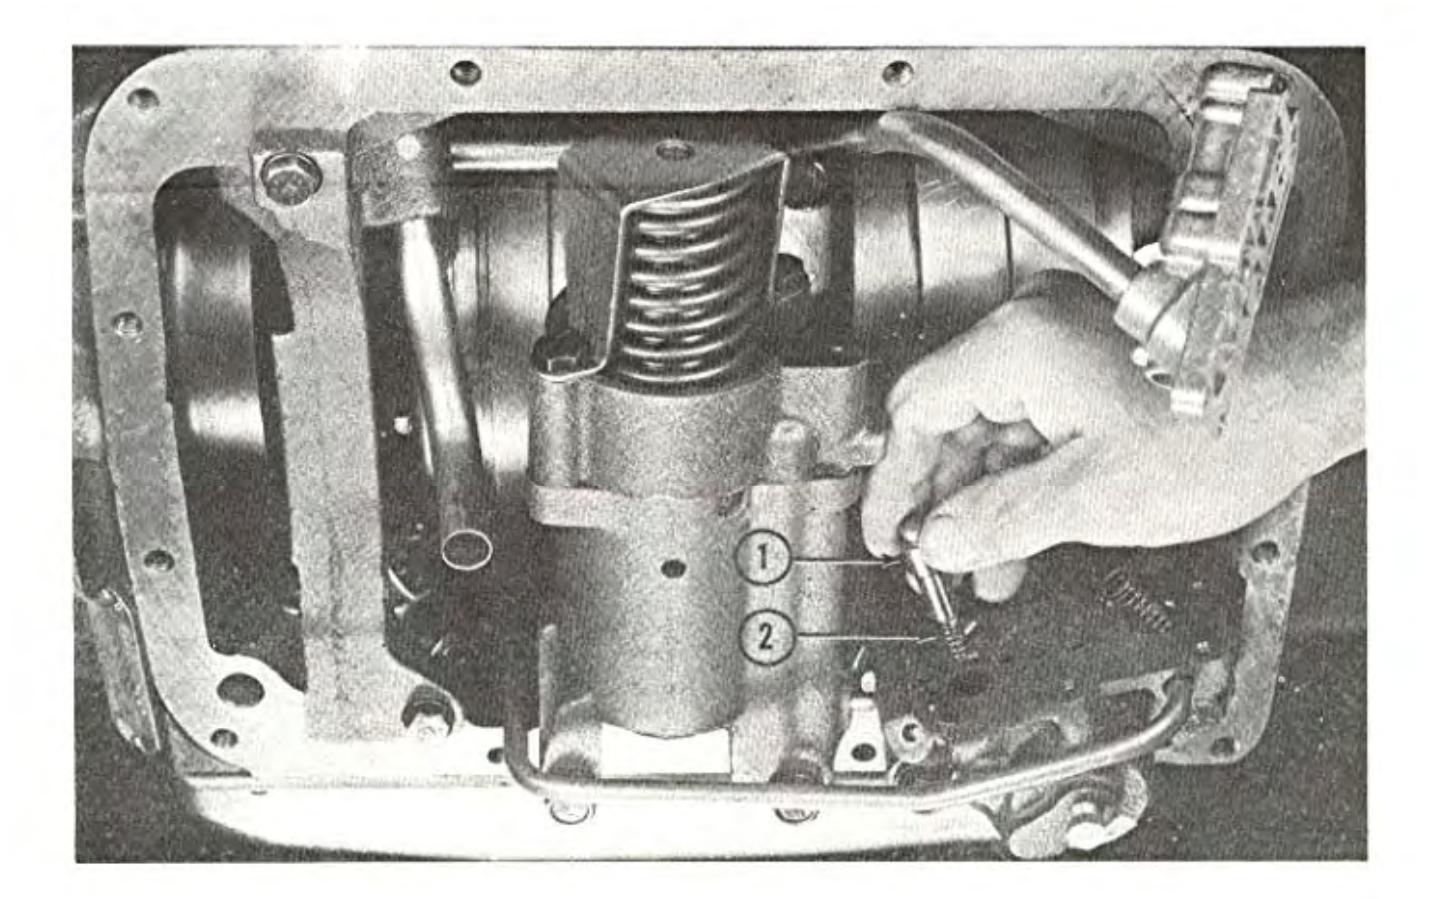
In cases where this condition is still prevalent after correction of the shift pattern through linkage and internal band adjustments, roughness can be eliminated by the installation of Service Spring, Part #3119206 in the front servo body 4-3 downshift valve.

1 - 4-3 Downshift Valve 2 - Spring Pt. #3119206

To install service spring, drain the transmission oil in a clean container, remove the oil pan and oil screen.

Remove the front servo valve body retained by the three filister head screws. The 4-3 downshift valve can be removed from the front servo body with long nose pliers or blown out with air pressure applied to the exhaust port hole. Insert the spring ahead of the 4-3 downshift valve; install the valve and replace the front servo valve body.
