HUDSON

Service Merchandiser

VOL 3 NO 1

JANUARY 1951

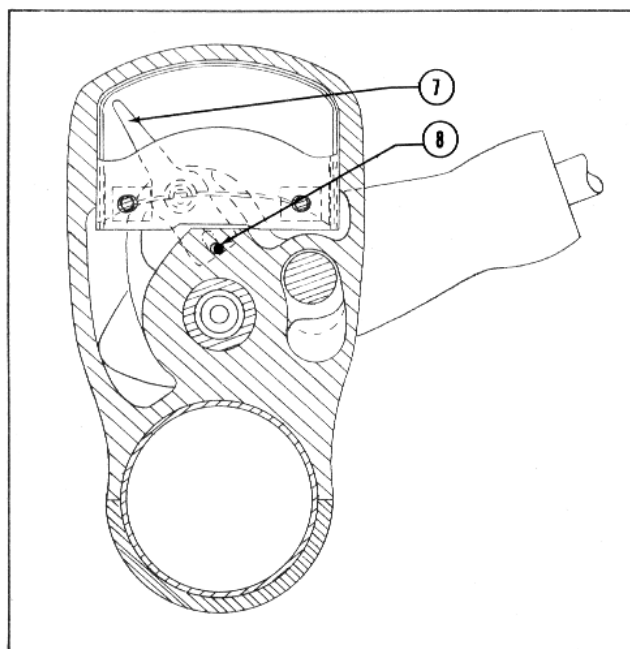
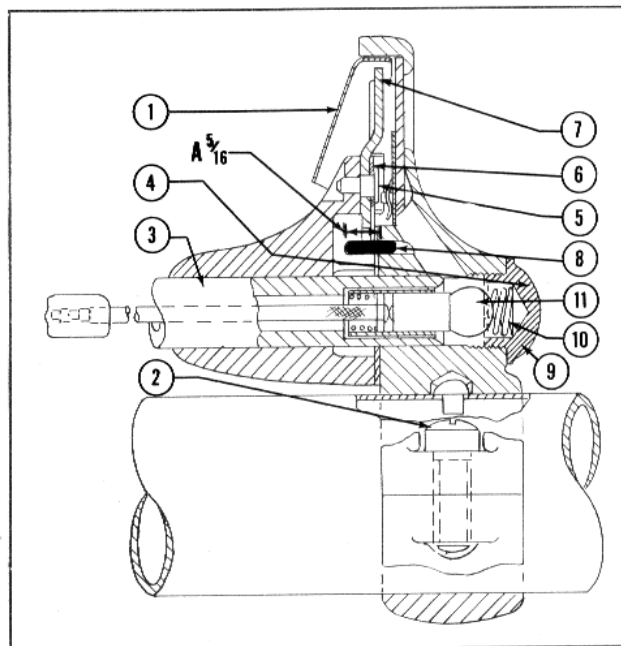
Breakage of the plastic indicator mounted on the transmission control tube bracket is in most cases caused by the drive indicator dial pin #8 (in illustration below) being too short resulting in the indicator being assembled with the pin not in proper position. This pin length has been increased from $\frac{3}{16}$ to $\frac{5}{16}$ of one inch. Procedure for replacement of the indicator and correction of the cause of breakage is outlined below.

Remove snap type cover (1) from transmission control tube bracket by light pry with screwdriver under cover. Refer to illustration below. (Space— $3\frac{1}{4}$ inches.)

Remove two screws (2) holding transmission control tube bracket and cap to steering column.

Lift up on shift lever to separate transmission control tube bracket from steering column and allow bracket to clear rivet head in steering column tube. In this position, transmission control tube bracket may now be separated from transmission control tube (3) and expose the drive indicator.

Using a small $\frac{3}{32}$ " punch, knock-out drive indicator pin (5) which retains drive indicator (7) and drive indicator spring washer (6) to shift control tube.

Replace broken drive indicator and reinstall spring washer and drive indicator pin in shaft control tube assembly.

Increase dimension of pin #8 in transmission control tube bracket to $\frac{5}{16}$ " as shown in illustration by pulling pin out of bracket with pliers to required dimension as measured from control tube bracket casting to end of pin. Remove all burrs from pin resulting from the above procedure.

Lift up on shift control tube and reinstall control tube bracket to shift control tube. Secure alignment of pin #8 and yoke of drive indicator (7) by moving

drive indicator with fingers during engagement of control tube bracket to control tube. Note: Do not use force in the above procedure.

Reinstall transmission control tube bracket cap to transmission control tube bracket and tighten cap screws securely.

To replace drive indicator bulb unscrew bulb retaining cap (9) from transmission control tube bracket and remove bulb retaining spring (10). (Space $3\frac{1}{4}$ inches.)

Lift hood and force wire terminal up inside of transmission control tube which will force bulb socket and bulb out of transmission control tube bracket. Bulb may now be replaced and installation accomplished by reversing the method of removal.

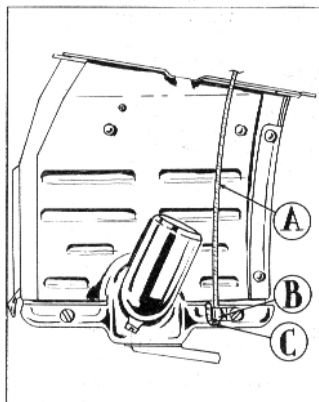
To improve response of the weather-control water valve and afford better thermostatic control of the heater, the control valve capillary tube has been relocated as indicated at "A" in the illustration. This allows forced air from the heater to pass over the capillary tube.

The capillary tube clip "B" Part number 301-889, is mounted facing the front of the heater and the end of the capillary tube is inserted through the clip and bent back 180° to secure the tube to the clip as shown at "C". Sufficient clearance should be provided between the capillary tube and the heater to prevent rattles.

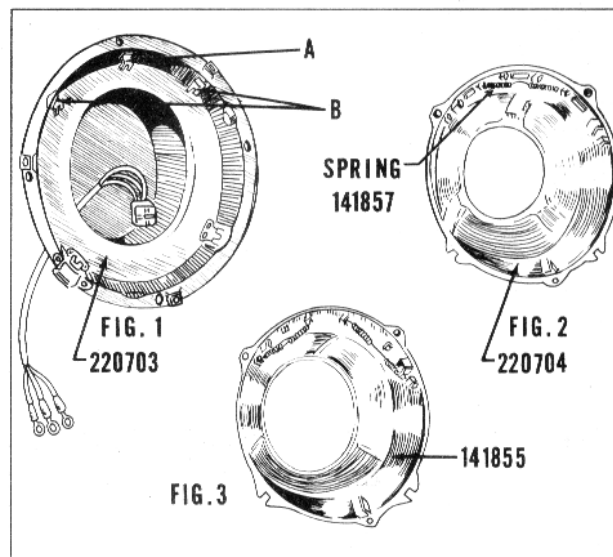
Headlamp Housing Assembly, #220703, as shown in Figure #1, may be used as a replacement Housing for all Models from 1940 to 1950.

When used as a replacement on models prior to 1948, Clips "B" in illustration Figure #1 are used to engage the retaining springs of Mounting Ring #141855, Figure #3, used on all Models 1940 through 1947.

Mounting Ring, #220704, Figure #2 is currently used on all Models from 1950 and uses a single retaining spring, retained by Clip "A" in the Headlamp Housing Figure #1.

Mounting Ring, #220704, may also be used as a replacement for #141855 on earlier Models, by the addition of a Retaining Spring, #141857, the springs then being relocated the same as shown in Figure #3 as provided for on the new Mounting Ring.
