EQUIPMENT AND SERVICE
SPECIFICATIONS

HUDSON - 1940-1947

TRICO**EQUIPMENT AND SERVICE
SPECIFICATIONS****Hudson**

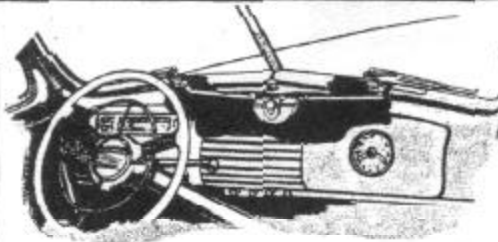
**INSTALLATION TYPE -2A**Estimated Time for Removal and
InstallationMotor **1/2 hour**
Motor and Linkage **1 hour**

Vacuum Source - Pump on some cars.

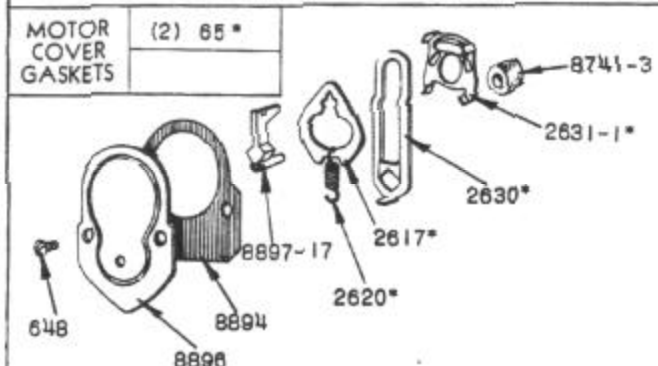
MOTOR VALVE PARTS

* PACKED IN REPAIR KIT WITH PADDLE ASSEMBLY

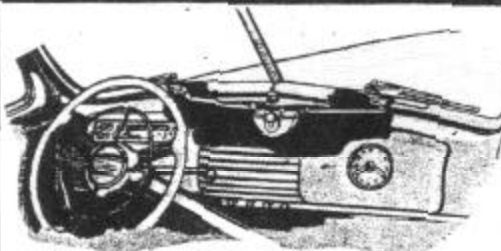
**INSTALLATION TYPE - 2A**
 Estimated Time for Removal and
Installation

Motor 1/2 hour
 Motor and Linkage 1 hour

Use bellcrank BC-46 with SK-704-1
as a replacement motor on this
model.

Vacuum Source - Pump on some cars.

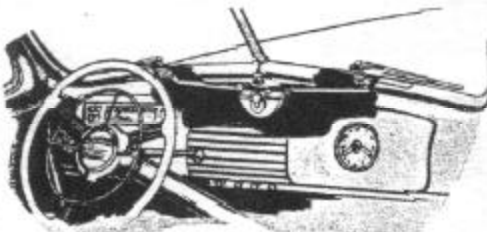
INSTALLATION TYPE - 2A

Estimated Time for Removal and
InstallationMotor 1/2 hour
Motor and Linkage 1 hour

Vacuum Source - Pump on some cars.

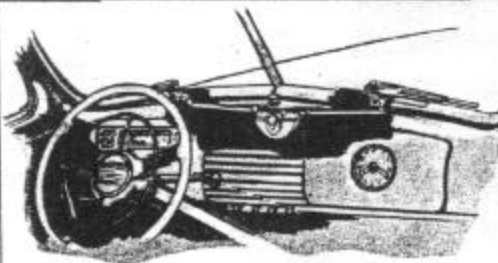
**INSTALLATION TYPE - 2A**Estimated Time for Removal and
InstallationMotor 1/2 hour
Motor and Linkage 1 hour**MOTOR REMOVAL**On model equipped with radio, it
will be necessary to drop the radio
before removing the wiper motor.**CONTROL**On 1946 models use control assembly
Part No. 77930-23A and control wire
Part No. 79138-1 for special radio
equipped cars.**ACCESSORY EQUIPMENT**Rear Window Wiper Set
Sedan Sp. 2476-1A

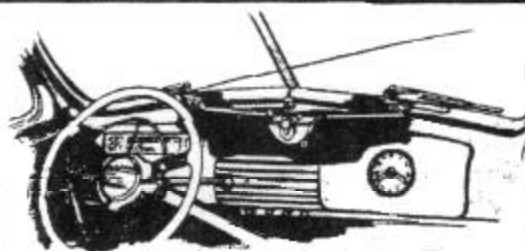
**INSTALLATION TYPE - 2A**

On model equipped with radio, it
will be necessary to drop the radio
before removing the wiper motor.

† Use control assembly Part
No. 77930-23A and con-
trol wire Part No. 79138-1
for special radio equipped
cars.

Rubber grommet inserts are used in
the linkage connecting arms and
hexagonal swaged type oilless bronze
bearing drive studs are incorporated
on the motor driving lever.

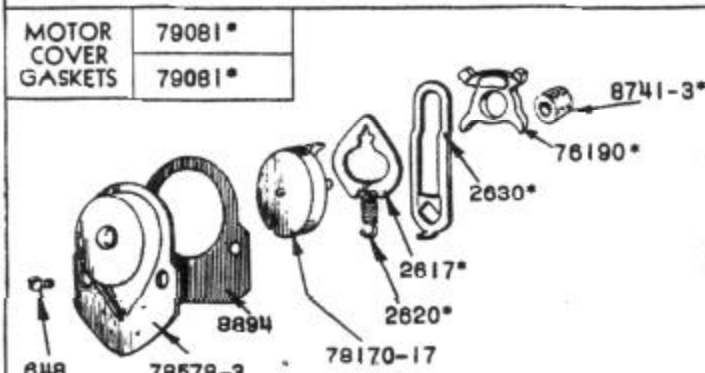
MOTOR VALVE PARTS

* PACKED IN REPAIR KIT WITH PADDLE ASSEMBLY
